GODDARD SPACE FLIGHT CENTER

Evaluation Report

Microcircuit (8)
Mfr.: Analog Devices
P/N: AD6640
D/C: 9951

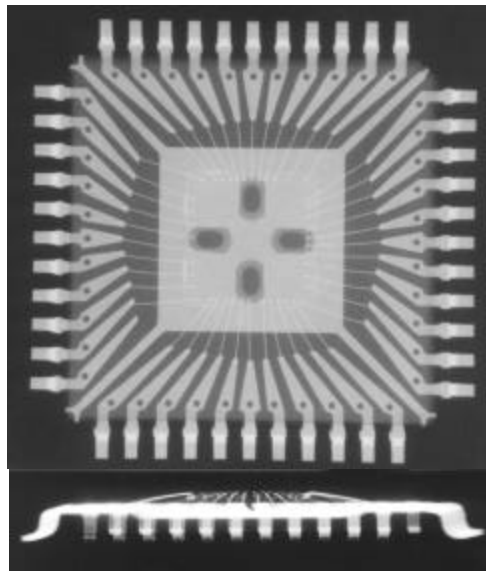
No package warping, cracks, voids, or foreign inclusions in the plastic encapsulant were observed. No gaps were observed between the entry of the leads and the molding compound. Radiographic examination showed adequate wire bond dressing. The die-paddle and the leads had lead lock holes which enhanced a bond between the molding compound and the lead frame and increased moisture resistance of the part.

Figure 2. Top and side radiographic views of the part showing adequate lead frame design, wire dressing and layout.

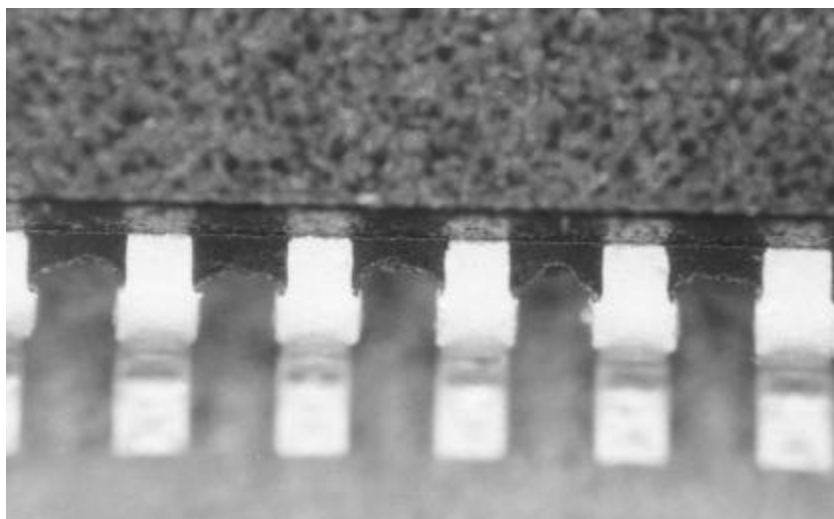
The between-leads space near the package in all parts was filled with the oozed molding compound (mold flash). Figure 3 shows a typical view of the mold flash. The oozed compound forms a thin layer which could be relatively easily broken during mounting of the microcircuits on the board. This might contaminate the board with polymer particles.

Figure 3. Mold flash between the lead entries.

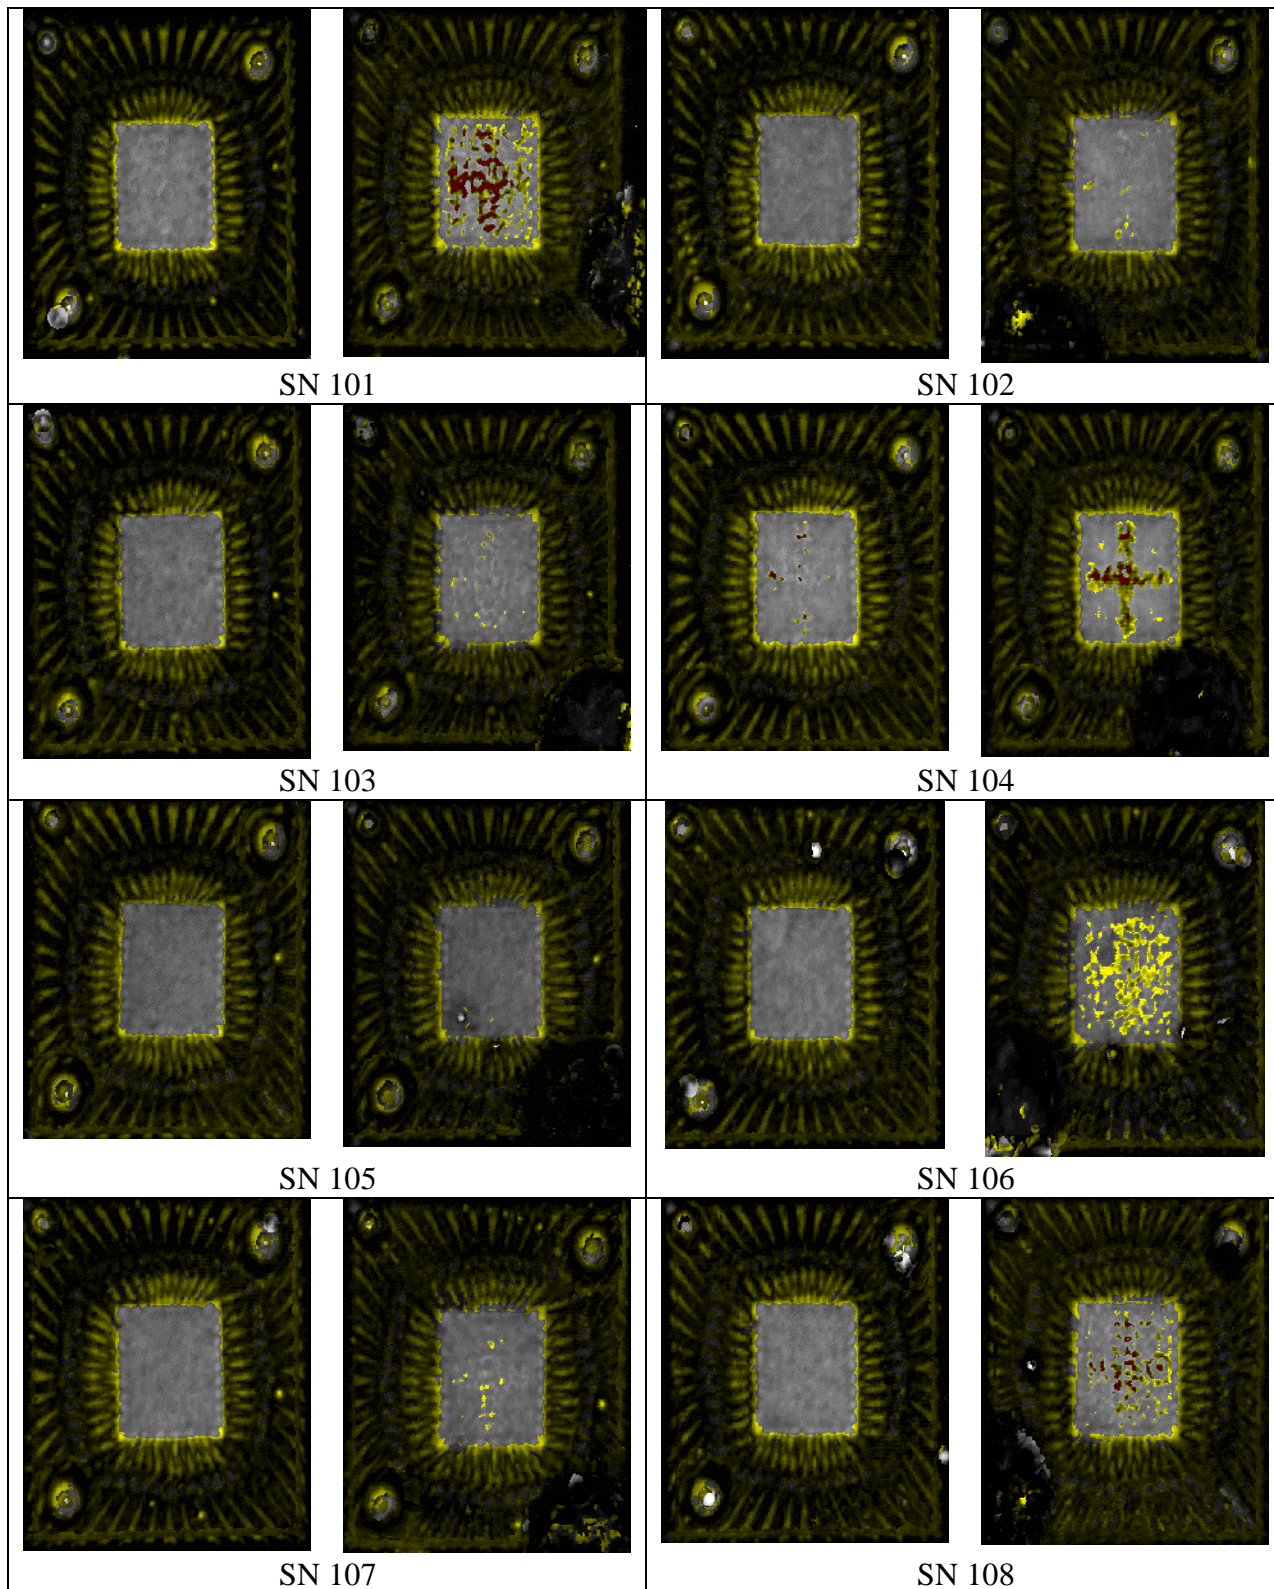
External visual examination did not reveal any defects. C-SAM examination showed that all parts had similar acoustic images (see Figures 4 and 5). No abnormalities at the die-molding compound interface or any other interfaces were noticed.

Figure 4. Initial (left) and post-SMT simulation (right) acoustic images. Top views.

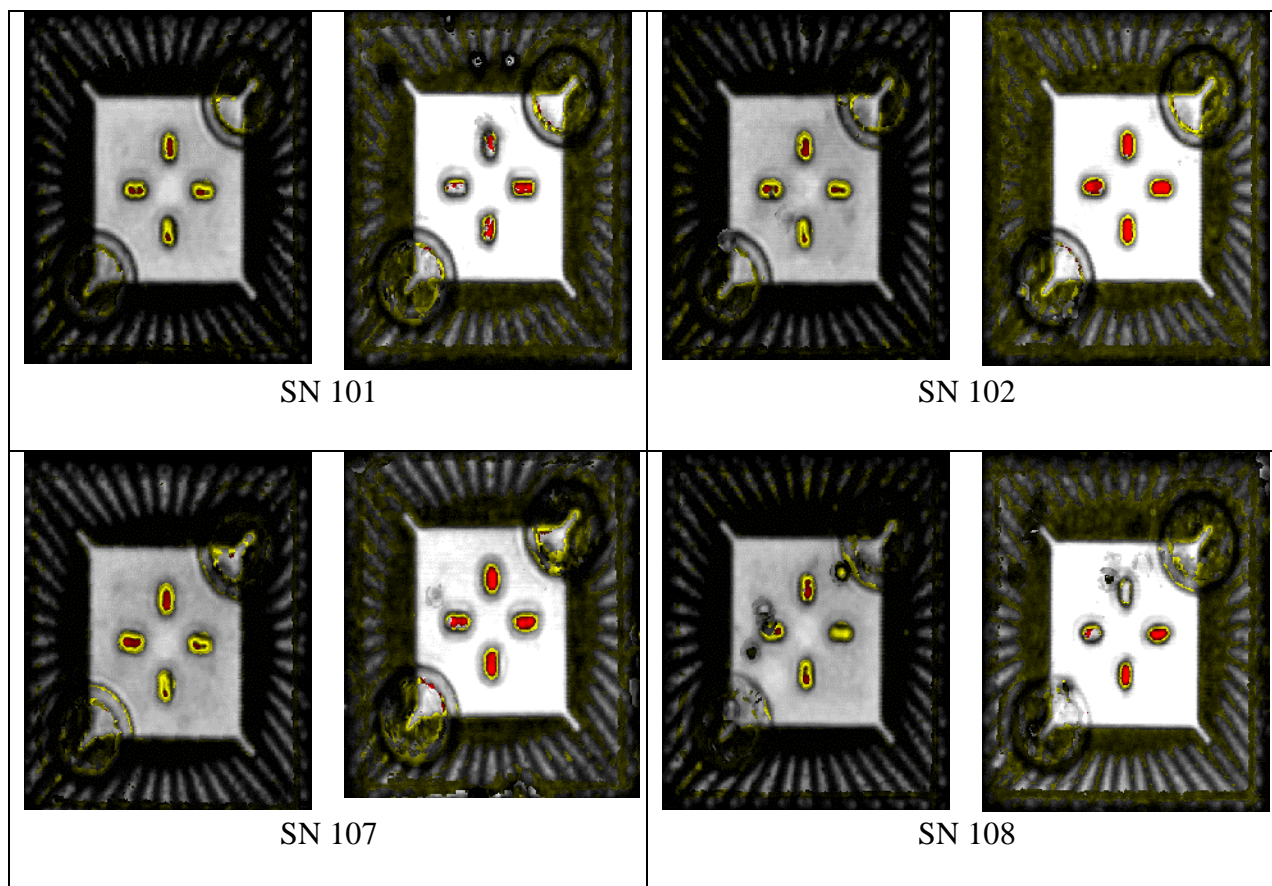
Figure 5. Initial (left) and post-SMT simulation (right) acoustic images. Back views.

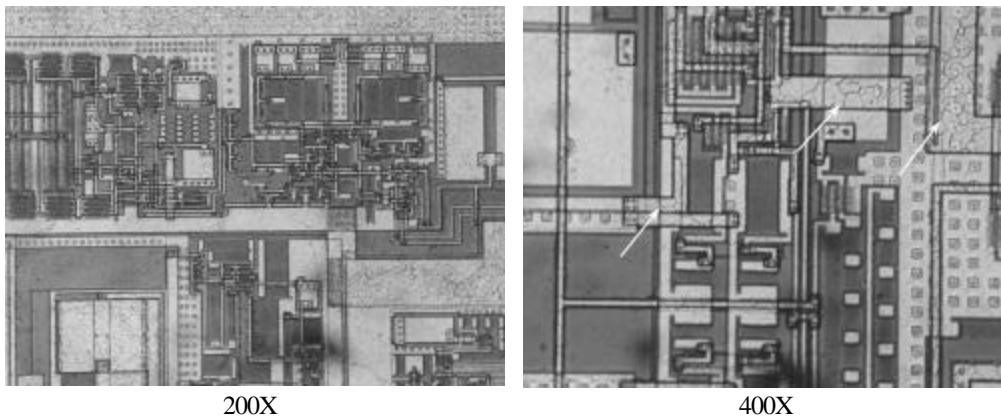
Two samples were decapsulated in red fuming nitric acid and examined microscopically. Figure 6 shows an overall view of the part after decapsulation and Figure 7 illustrates typical views of metallization patterning. No abnormalities were found except for somewhat large grains of aluminum metallization. The identification marking on the dice was "BCOM, 1997, 6640-R2".

Figure 7. Optical views showing the large metallization grains.

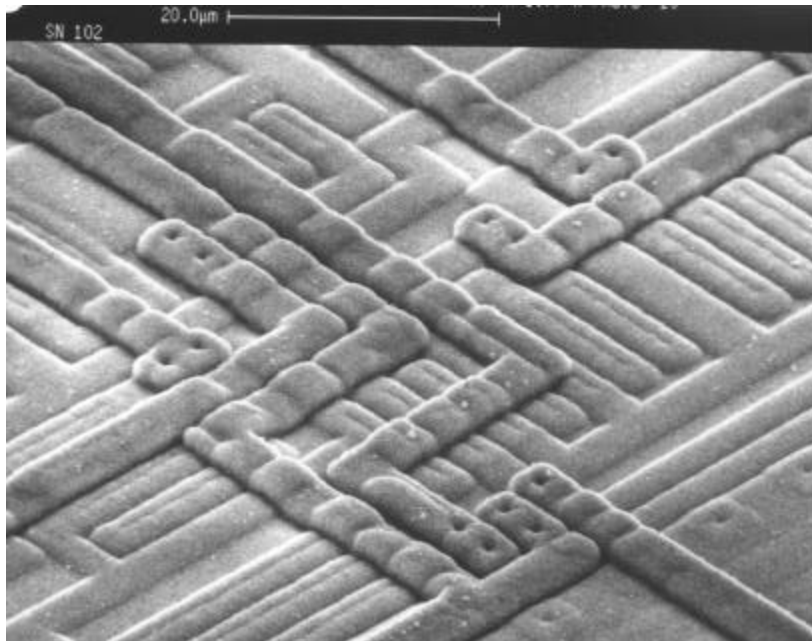
Bonds and glassivation in two samples were inspected using a SEM. No glassivation or bonding defects were found (see Figures 8 and 9). Energy-dispersive X-ray microanalysis (EDX) indicated that the glassivation was composed of a nitride film overlaying a silicon oxide film.

Figure 8. SEM view of the glassivation showing good coverage over metallization.

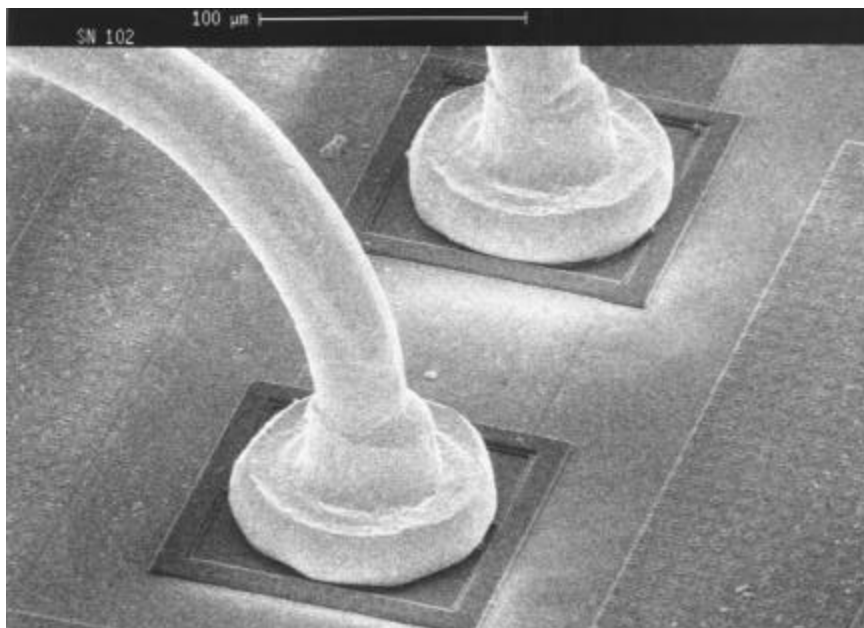
Figure 9. Typical gold wire bonds show acceptable deformation and placement.

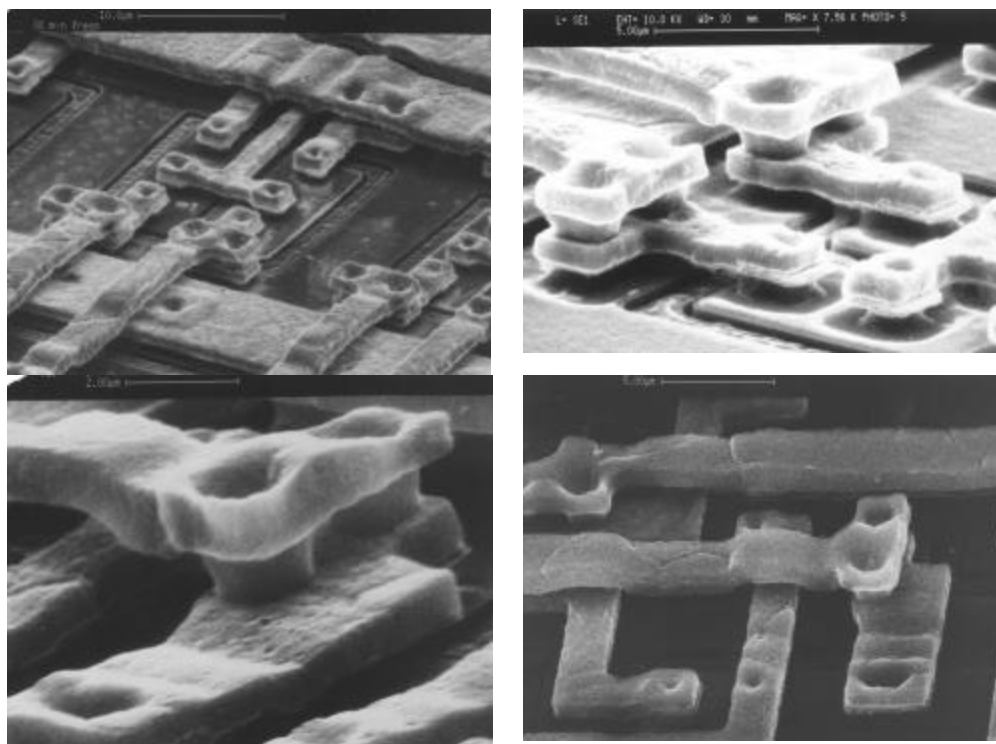
The metallization was inspected in one sample per MIL-STD-883D, Method 2018 after glassivation removal. The part is designed with two aluminum metallization levels. No patterning problems, misalignment, or other defects were found in either the top or the bottom metallization layers. The first level of metallization employs a thin Ti/W barrier layer. The part has adequate planarization which significantly reduced the step coverage problem. Figure 10 shows details of the metallization system.

Figure 10. SEM views of the first and second levels of aluminum metallization showing good alignment.

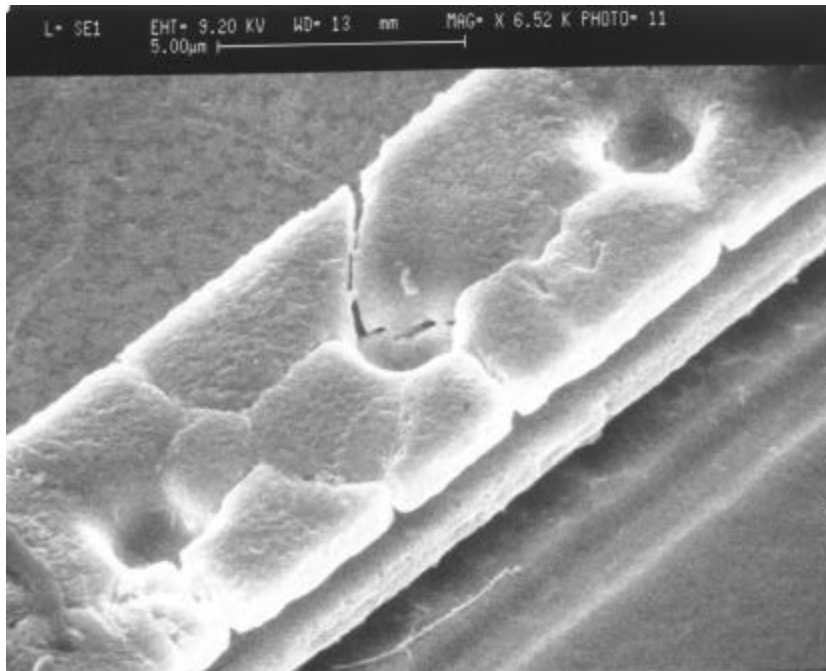
SEM examination confirmed large grain size in the aluminum metallization and revealed defects which appeared to be intergranular cracks (see Figure 11). However, metallization grains are known to be preferred locations for chemical attack and the observed defects are artifacts caused by SiO₂ wet etching. Large grain size increases conductor life at high current densities by reducing the risk of electromigration failures. Considering the good protection characteristics of the used glassivation system and the fact that the part is not intended for operation in moist environment, the large grain size of the metallization most likely will not compromise the reliability of the part.

Figure 11. Aluminum run fractured along the boundary grains.

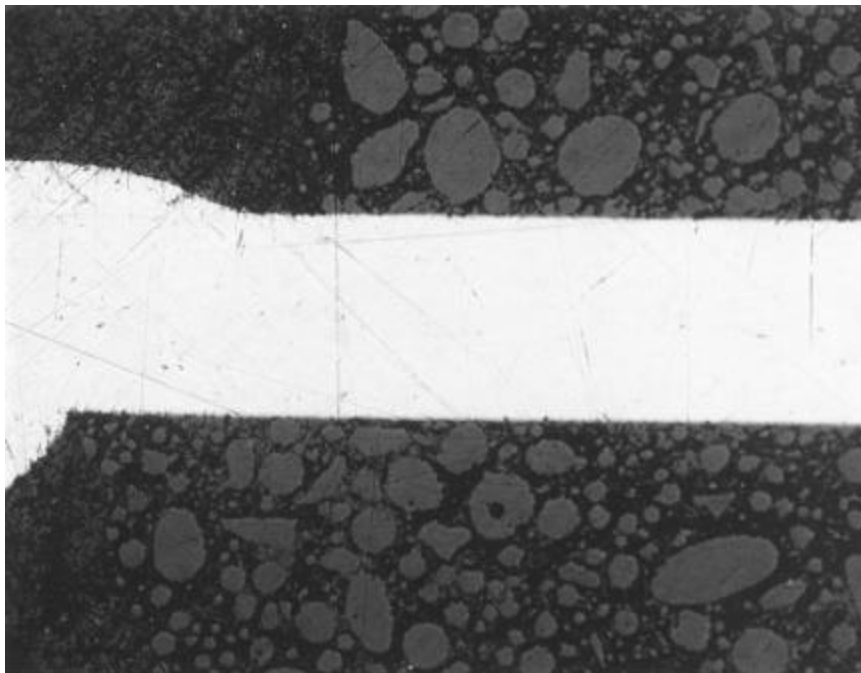
The molding compound had no cracks or voids and formed intimate contact to all internal surfaces (die, wires, and lead frame). No delaminations between the glassivation and the molding compound were observed. Although crevices at the lead entry to the package are a common defect in plastic encapsulated microcircuits, the cross sectioning showed that the leads in these parts were completely embedded in the molding compound without any gaps at their entry (see Figure 12).

Figure 12. Cross section of the lead entry.

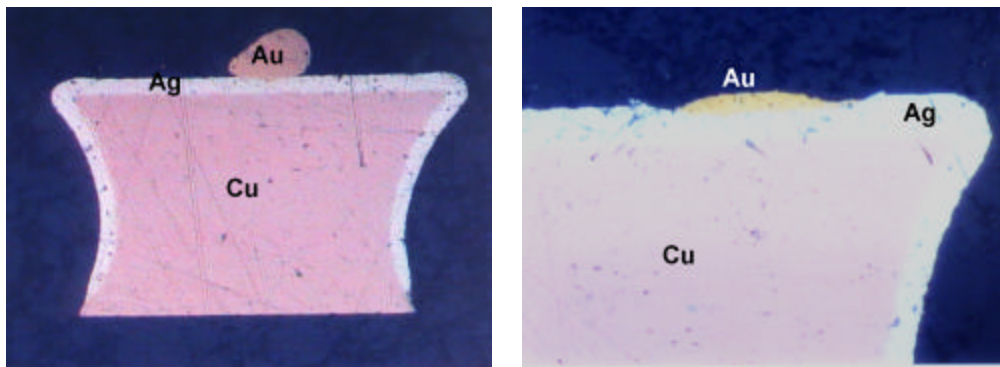
The gold wires formed metallurgical contacts with the silver plating at all examined wire-to-lead frame bonds (see Figure 13). Ball bond cross sectioning showed the formation of an adequate Au/Al intermetallic layer of 2 - 3 μm in thickness (see Figure 14).

Figure 13. Stitch wire bond to the lead.

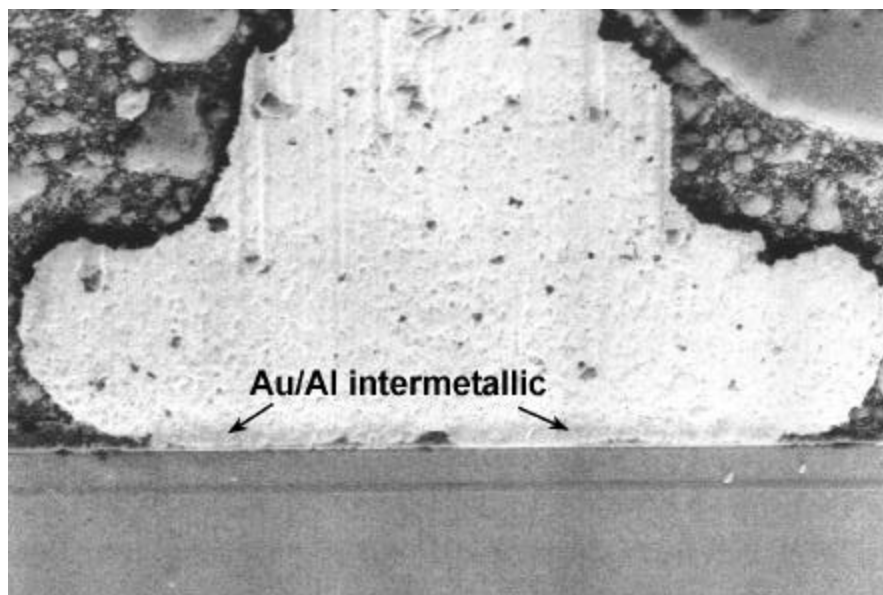
Figure 14. Cross section of the wire bond showing adequate Au/Al intermetallic formation.

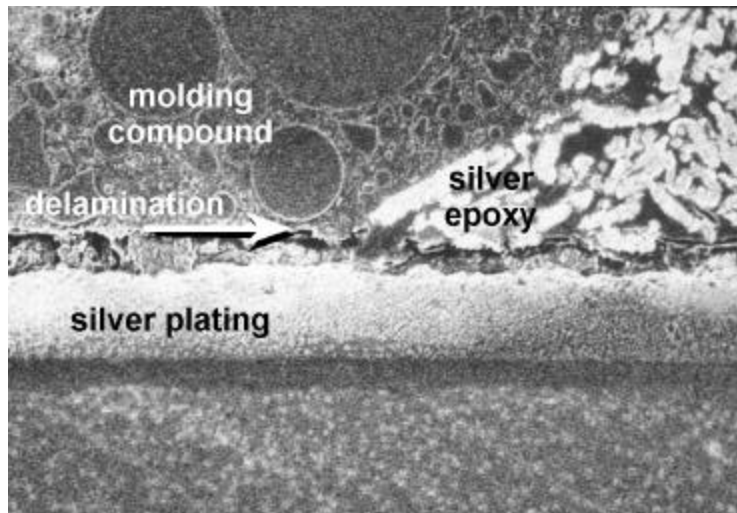
The die was mounted to the lead frame base with a thin layer of silver epoxy. The silver filler was uniformly distributed along the adhesive layer. A minor delamination at the silver epoxy-to-paddle interface (see Figure 15) is common for similar designs and does not pose any reliability risk.

Figure 15. Delamination along the top of the lead frame paddle.

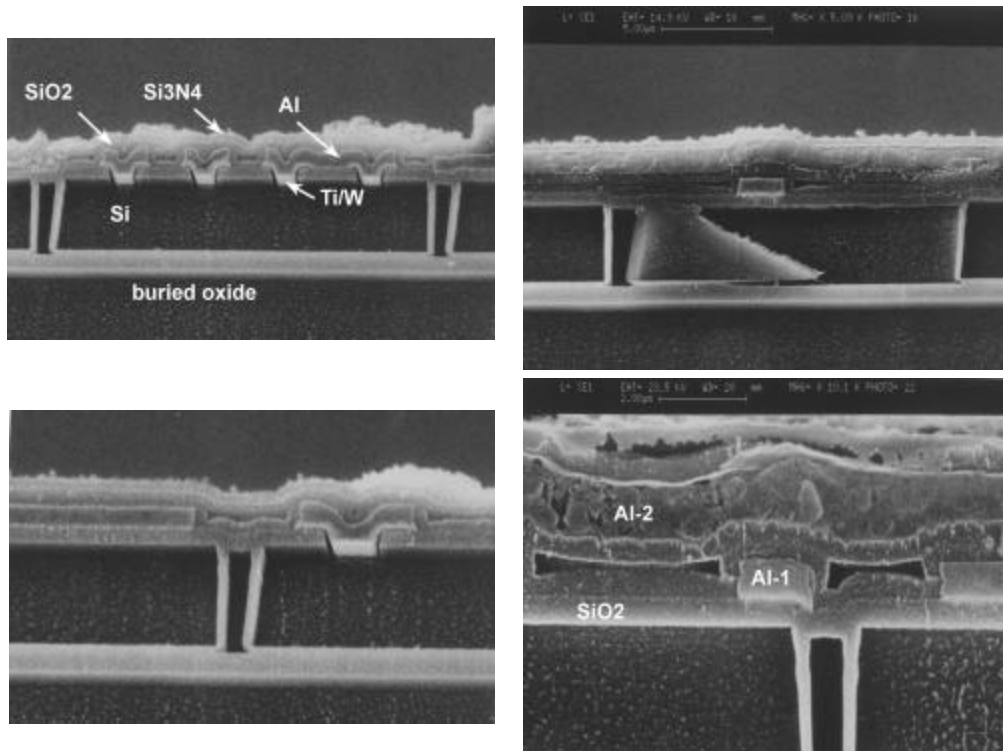
Figure 16 shows typical cross sections of the die. The part is designed using a relatively thick buried oxide and silicon film (1.2 μm and 4.5 μm respectively). This is typical for the bond and etch-back SOI technology and provides better insulation and quality of the active silicon layer compared to the SIMOX process.

SEM examination of the die cross-sections did not reveal any defects in the dielectric trench or lateral isolation and/or in the metallization system.

Figure 16. Cross-section views of the die showing buried oxide and silicon active areas. Note adequate step coverage of the passivation layer.
